Manhole Inspection Summary

Manhole # S33UU1006MH

Location Address: **220 GOODALE RD**

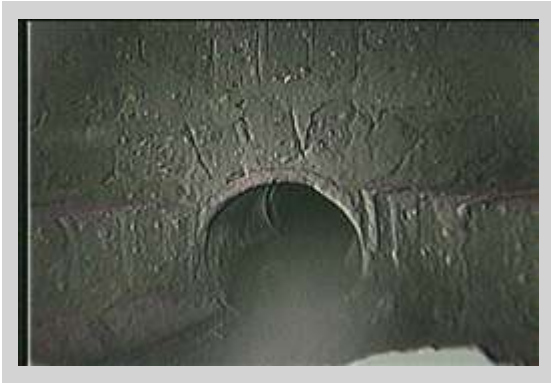
8 in. Circular Gravity Sewer Pipe Out @ 12 O'Clock

Rod and Bar (Angled)

Pipe Material: **Clay** ☐ Pipe Lined

Infiltration: **None** Pipe Seal Cond: **Unknown**
